Idaho Nonpoint Source Program

2003 Field Evaluation Progress Report

Idaho Department of Environmental Quality

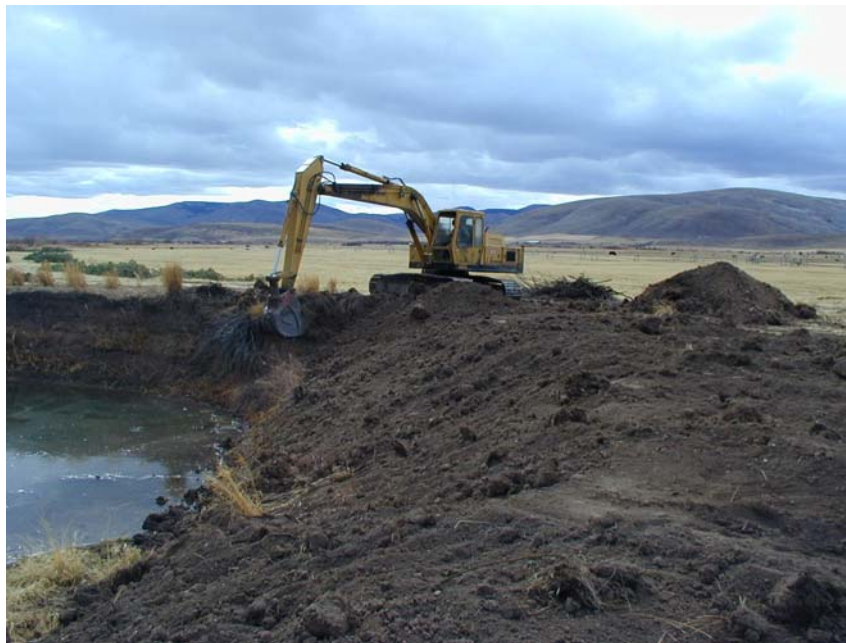
Figure 6: Heavy equipment used to move soil and place large rocks for stream bank stability.

Figure 6 illustrates the effect of bank shaping. Left of the trackhoe is a vertical face, nearly 10 feet above the Thomas Fork Creek (at normal flow). A reduced bank angle provides more floodplain for high flows and better dissipates energy associated with those flow events. Moreover, once the angle of the banks has been reduced to a less critical slope, other techniques are applied to keep the stream bank from reverting to a 90-degree angle.

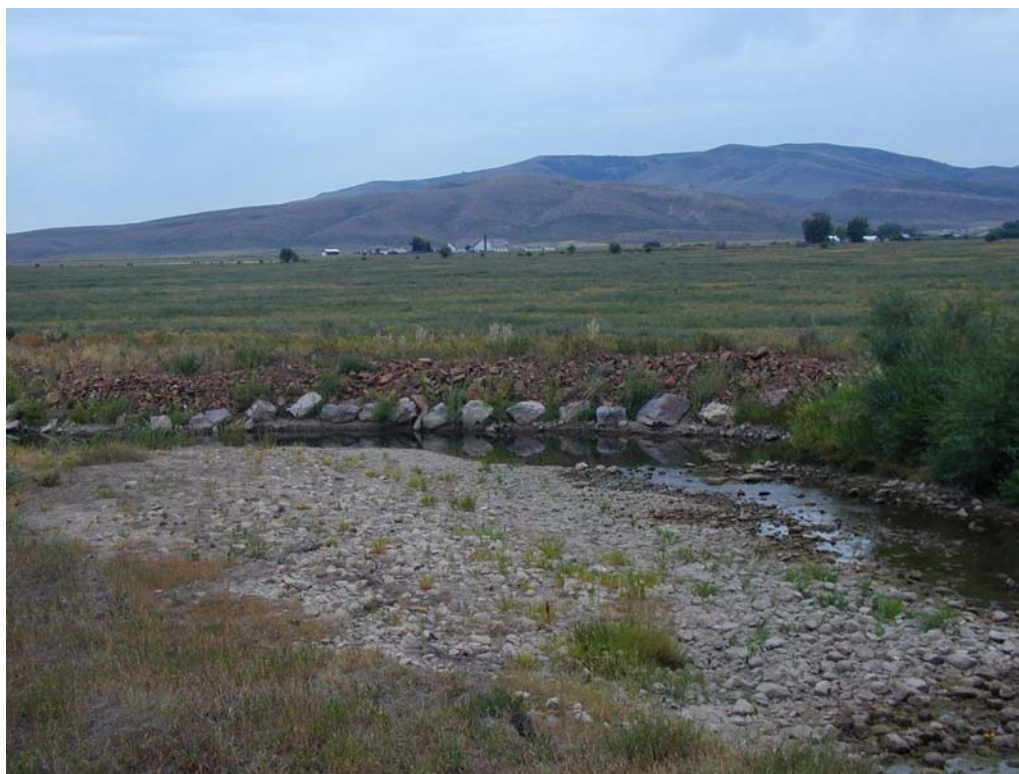
Figure 7: Toe armoring and rip-rap bank protection techniques

The toe of the slope also benefits from this same technique. Rock is laid end-to-end along the water’s edge, and this rock, like that used for rip-wrap, is hard, angular, and dense—but of greater diameter. These rocks are typically 2-3 feet in diameter and are placed by trackhoe, one at a time, rather than by the bucket load.

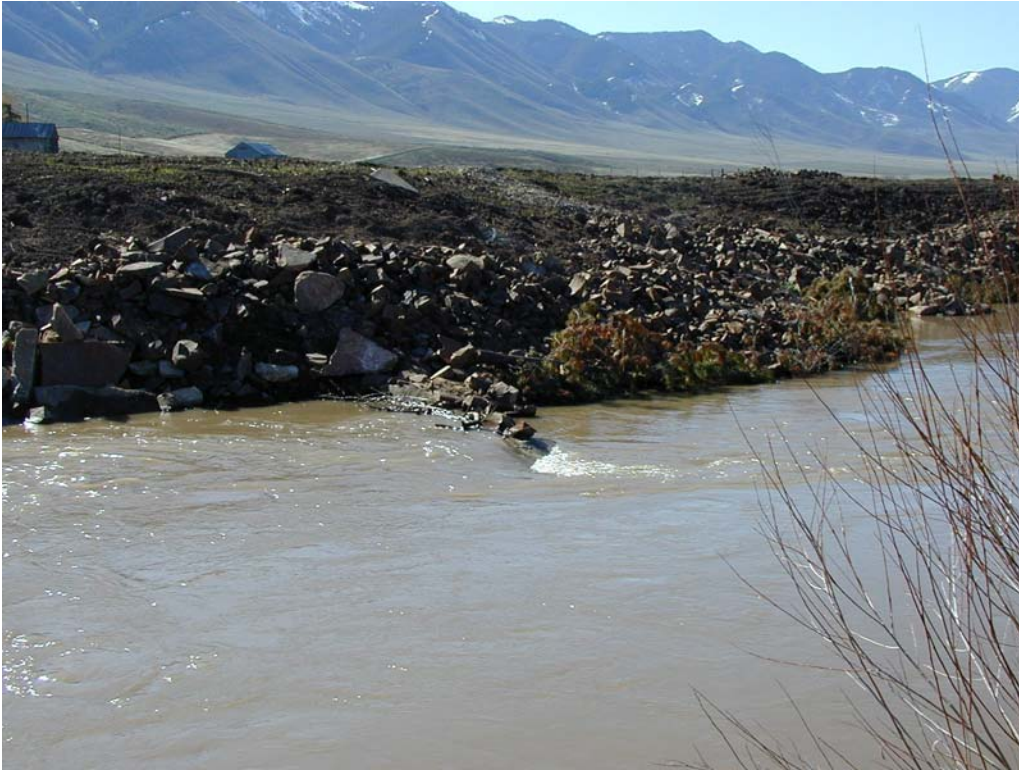
Figure 8: Flow deflector or 'bank barb' diverting flow away from sensitive areas

Flow is diverted away from sensitive banks with the use of flow deflection structures (Figure 8). Often referred to as “bank barbs” or “points,” these structures are composed of the same material that covers the exposed banks, only larger and placed specifically according to engineered plans. Large rock is laid end-to-end, pointing upstream, at a 45-degree angle from the bank. Smaller rock is then placed over the large rock to fill interstitial spaces and reduce flow velocity between larger rocks. A key trench is dug into the bank to anchor the structure in place.

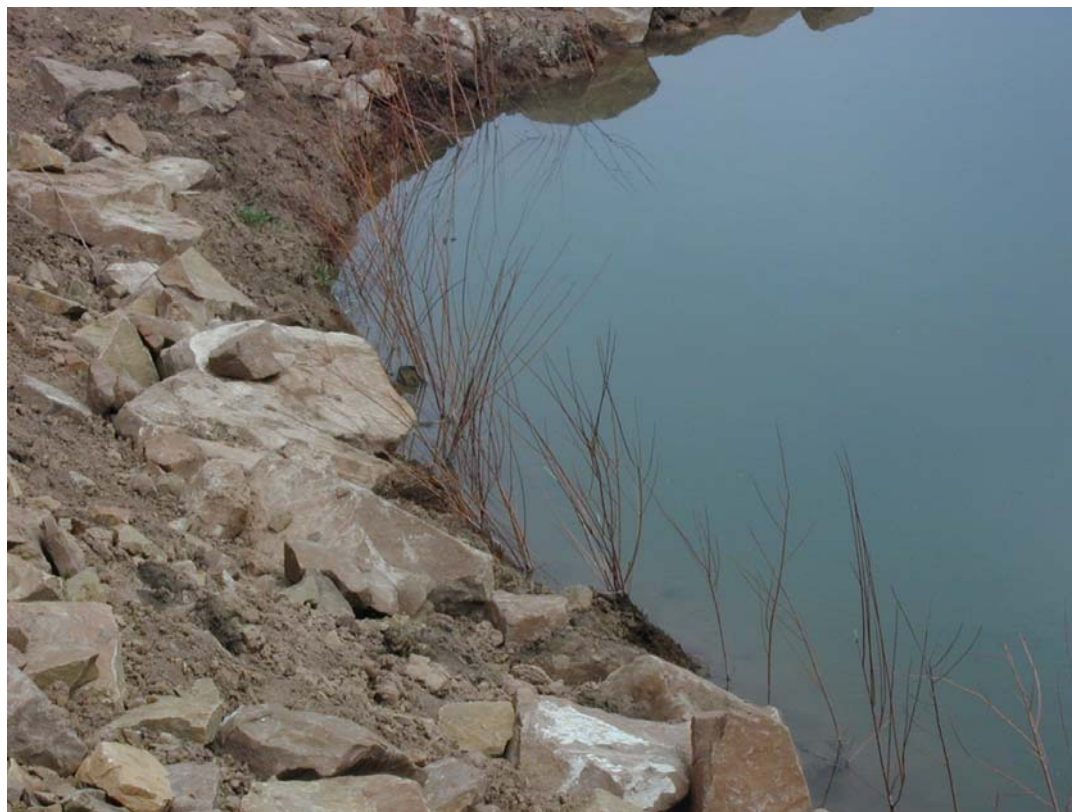
Figure 9: Willow cuttings pressed into toe of bank slope

Revegetation, which provides long-term sediment and nutrient reduction in addition to other benefits, consists of planting willows (Figure 9) and other on-site vegetation, along with broadcasting a native seed mix on affected areas.

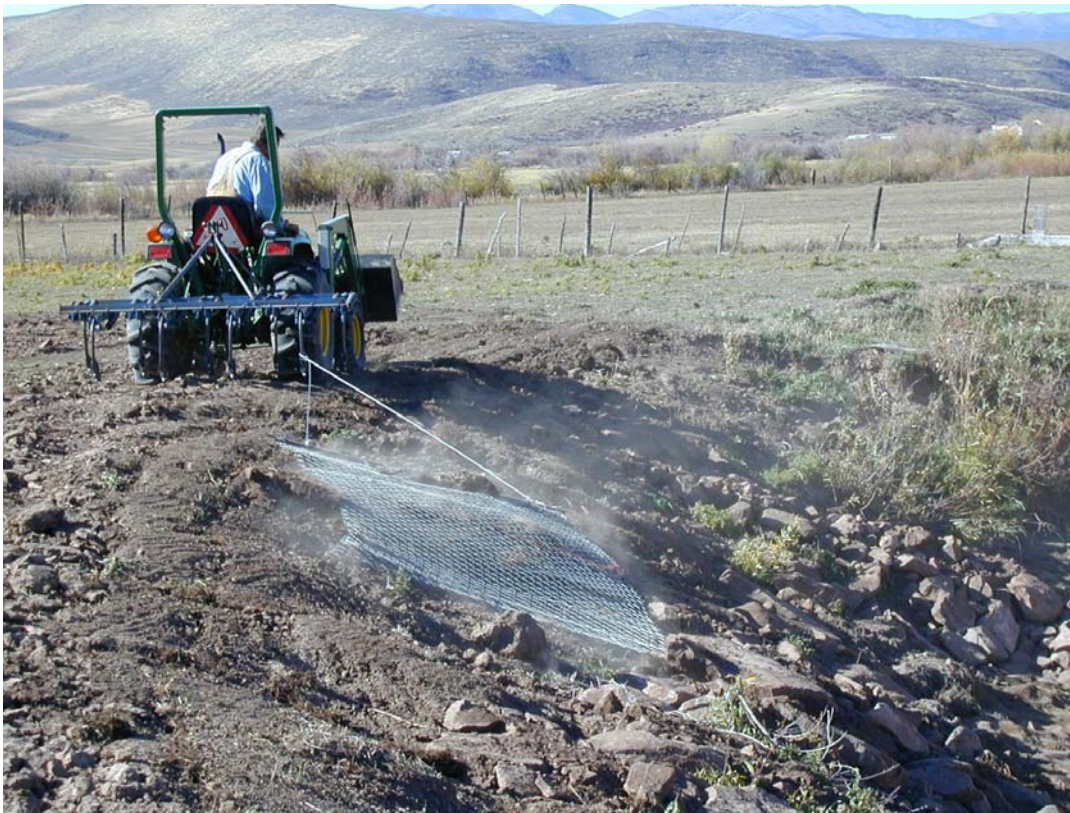
Figure 10: Harrowing soil after broadcasting seed

As a final step, seed is broadcast by hand just prior to snowfall—at the recommended density of 30 pounds per acre—then treated by dragging a harrow over the soil.

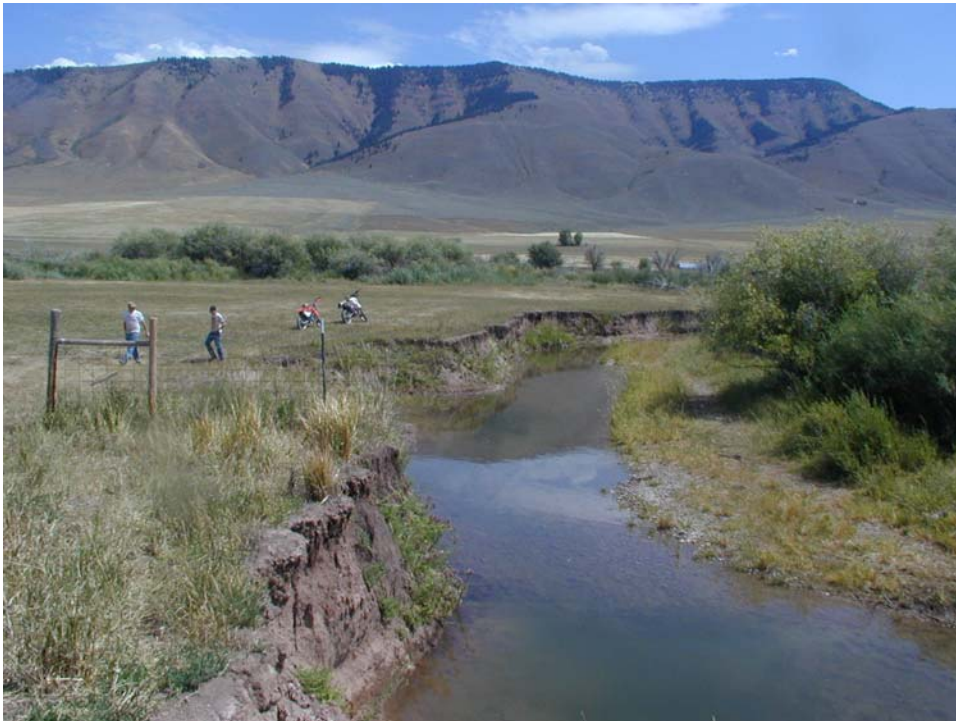
Figure 11: Prior to implementation of BMPs (Fall, 2002)

This project required treatment of 2,163 linear feet of stream bank and construction of 12 bank barbs. Ecological enhancements include three new pool-riffle complexes and re-defined thalweg (deepest point of the channel). Other improvements of interest at this location include reduction in stream width-to-depth ratio at three locations because of newly formed gravel beds.

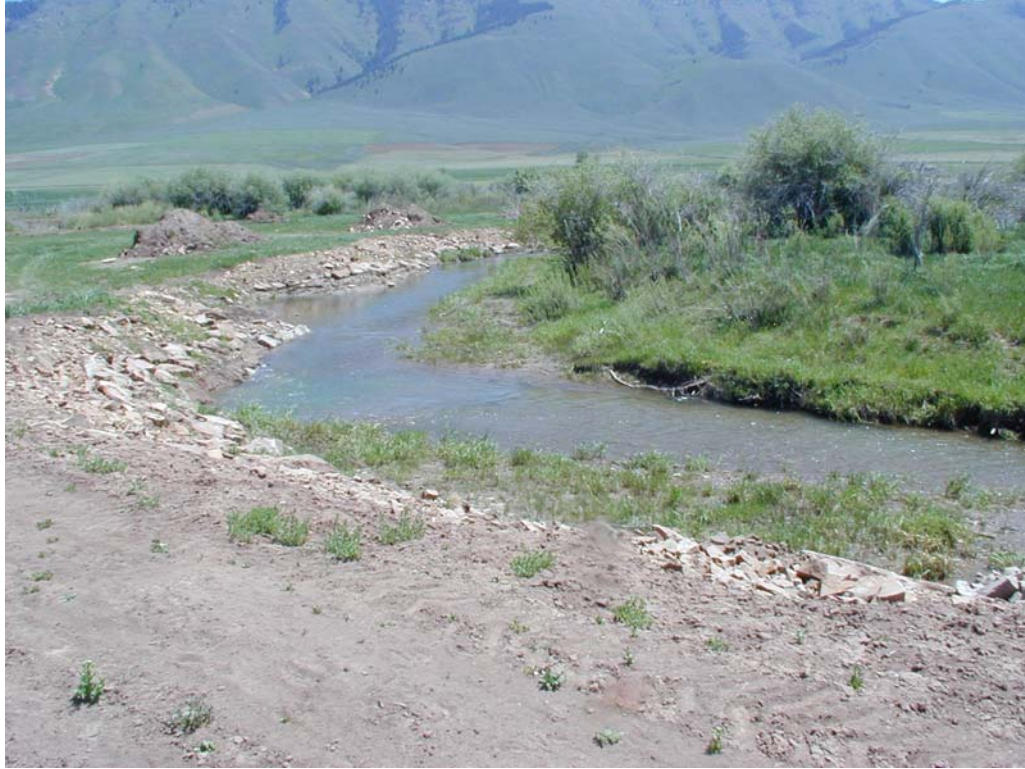
Figure 12: Post-BMP implementation (Spring 2003)

This is the third bank stabilization project that landowner Garth Boehme has participated in. The photos of Figure 11 and Figure 12 were taken in the fall of 2002 and spring of 2003 after construction. Of particular interest is the width of the channel in these photos. Prior to construction, the creek spanned the channel, but after reducing the angle of the bank and constructing a bank barb, the channel width was reduced. Also of interest is the amount of sediment deposited next to the bank. This occurred during a two-month period over the spring runoff. Because of the recently aggraded gravel bar, new emergent vegetation is starting to take root.

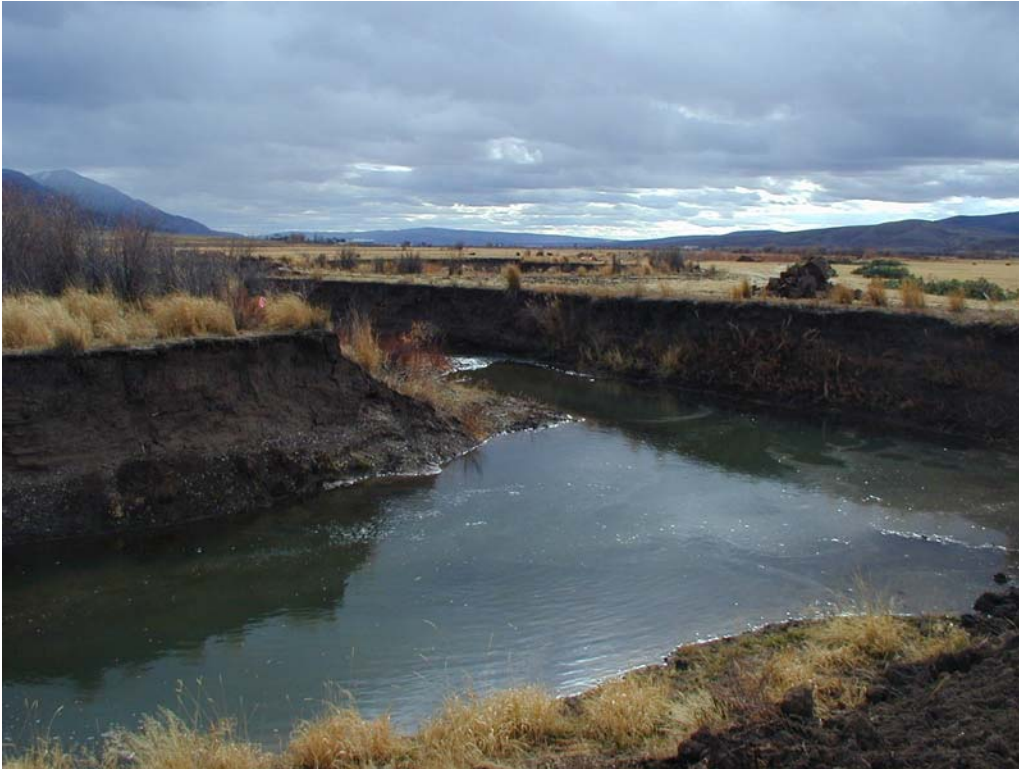
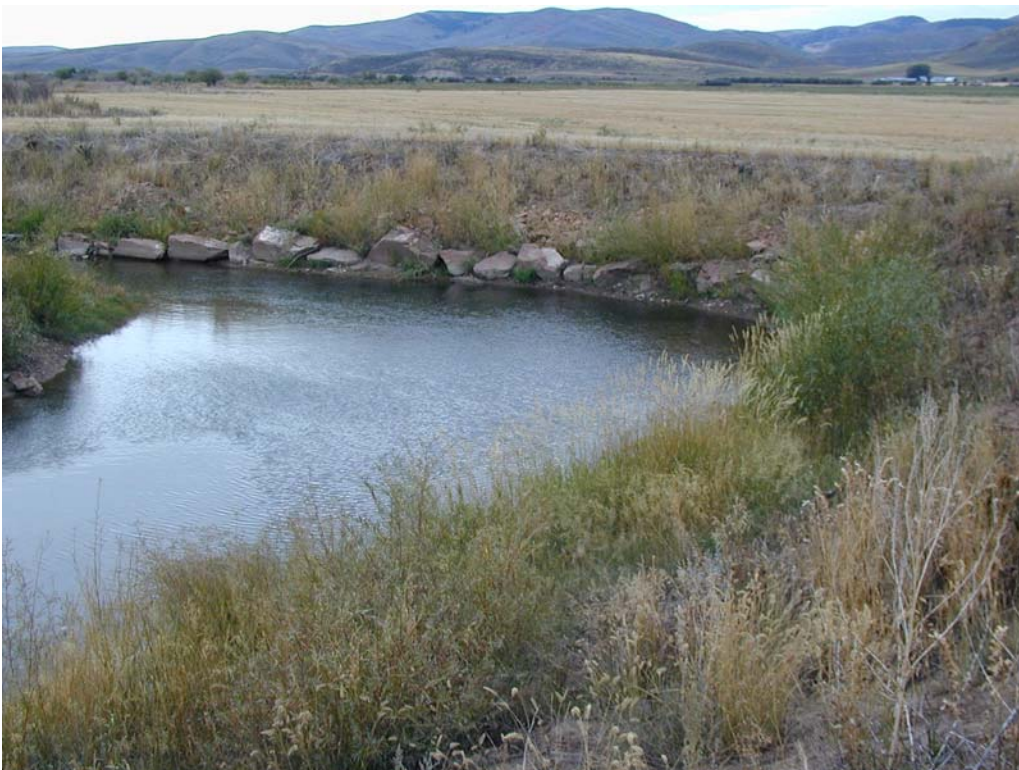
Often banks are found to be eroding at transitional areas between cut banks on corners. Figure 13 and Figure 14 illustrate how little time is required for riparian vegetation to re-establish on the banks once the soil is stabilized in place using BMPs. The time lapse between the photos is roughly six months. Treatments along 4,275 linear feet of stream bank and 15 bank barbs were required at this project. Roughly, 2,100 linear feet of log revetments were used as additional retention devices at strategic locations.

Figure 13: Cut banks prior to reclamation

Figure 14: Cut banks six months after reclamation

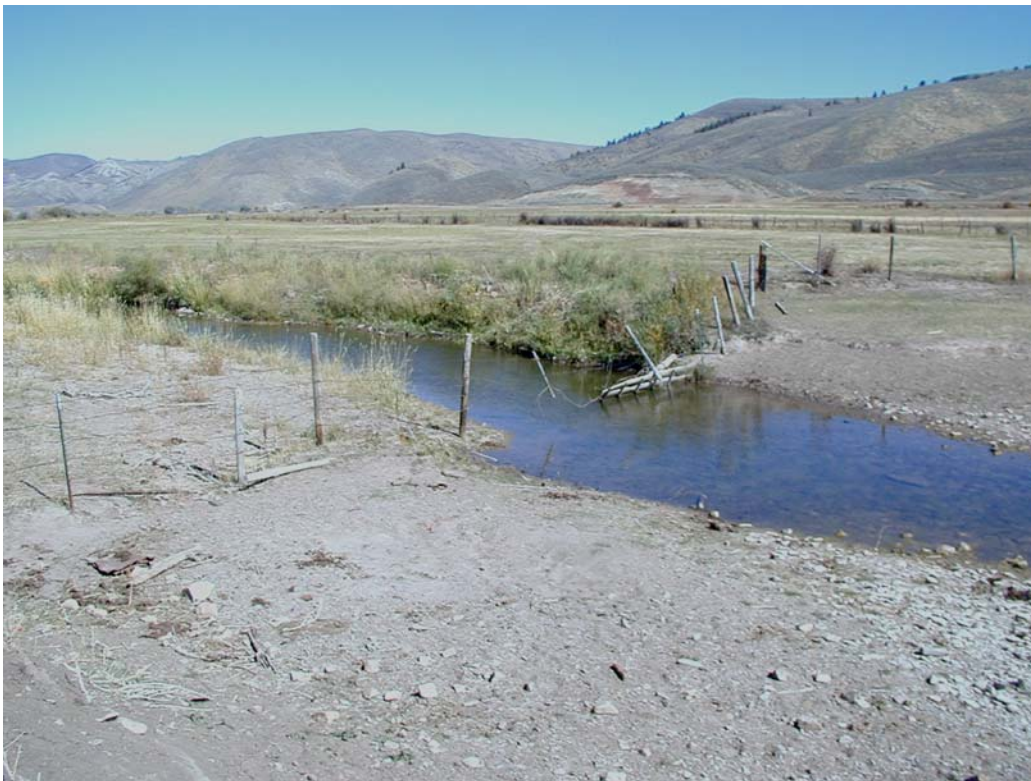
Figure 16: Illustration of the benefits of treated versus untreated land

Further illustration of the benefit of BMP implementation can be seen in Figure 16. The left side of the picture is Heber Boehme's property after treatment with BMPs and allowing re-establishment of riparian vegetation. The right side of the picture lacks BMPs and an alternative to grazing management. Prior to treatment, both sides of the fence looked like that on the right side. Clearly, implementation of BMPs and landowner cooperation results in a distinct improvement. Bank shaping and other treatments on this project totaled 1,743 linear feet with placement of 13 bank barbs.

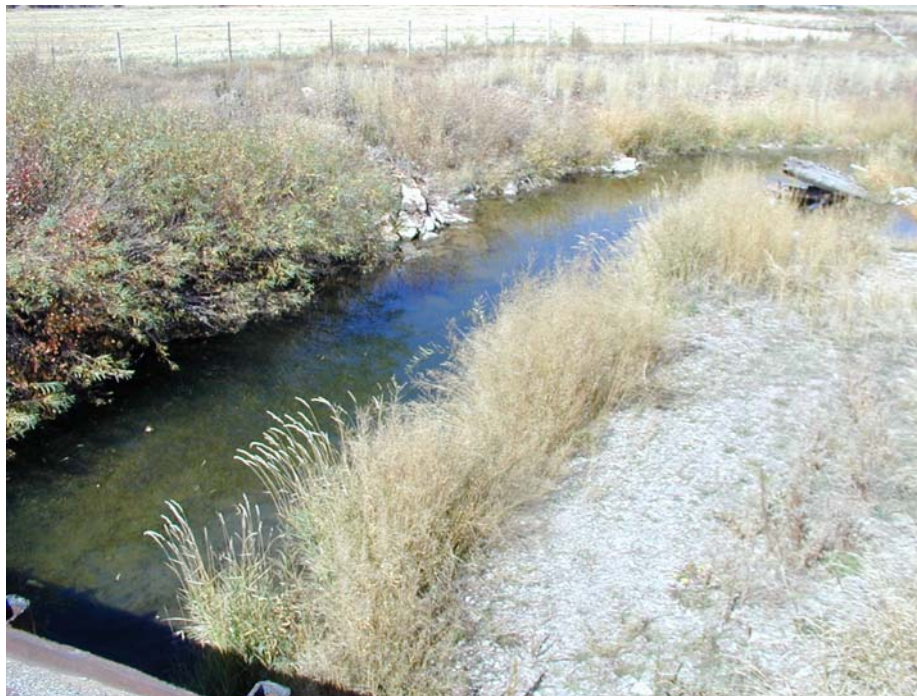
Figure 17: Vegetation and stream channel after six years

The other benefit in this area is the gravel bed, which has aggraded vertically and horizontally and reduced the channel width. Treatments at this location include: bank shaping along 1,500 linear feet, 900 feet of log revetments, and 15 bank barbs constructed at strategic locations. In addition, 2,000 linear feet of fence were erected for livestock exclusion.

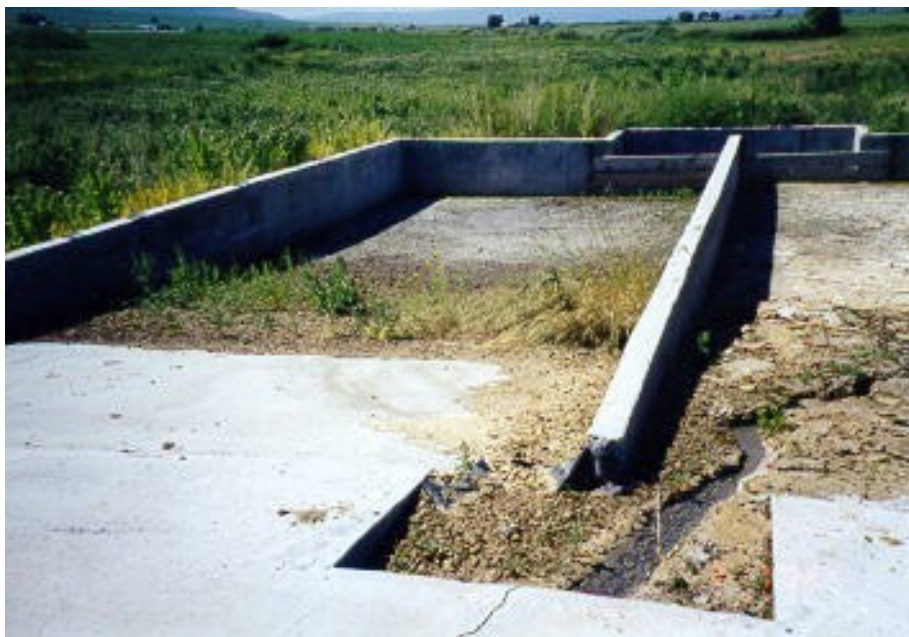
Figure 18: Manure bunker with wetland in the background

In addition to bank stabilization and BMP implementation on Thomas Fork, other upland projects have been completed as well. A manure management facility, consisting of a manure bunker, separator and constructed wetland, has been completed to reduce nutrients entering Thomas Fork (Figure 18). The constructed wetland helps to take up much of the nutrients that previously entered Thomas Fork.

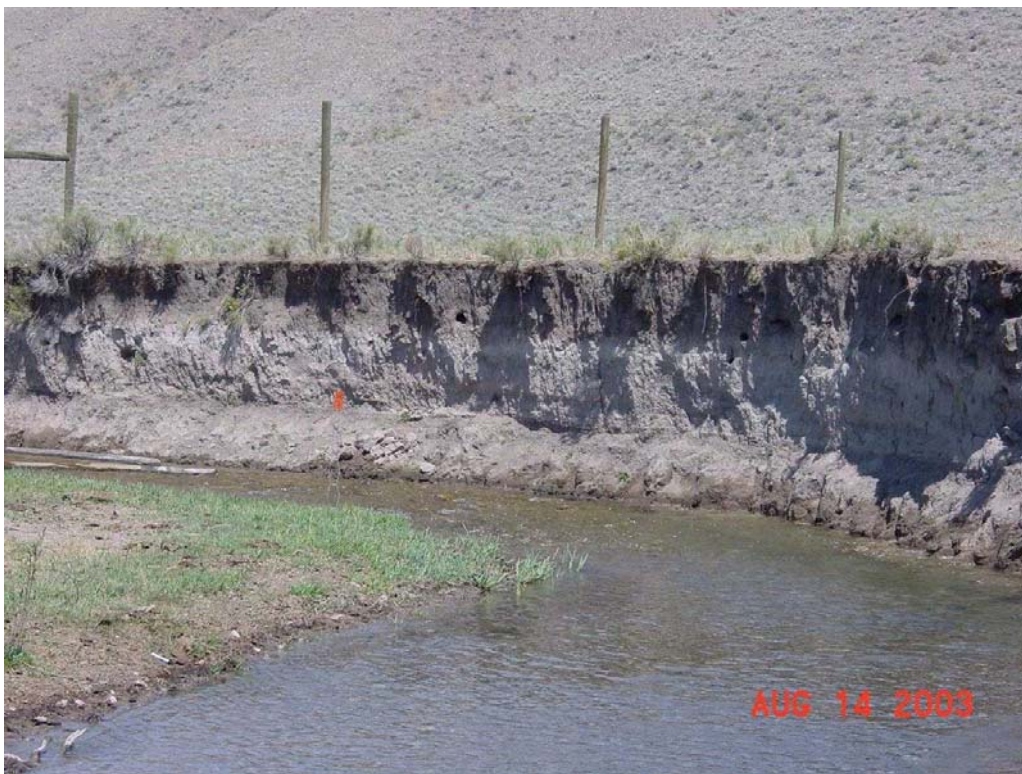
Figure 22: Problems that are routinely found along Medicine Lodge Creek include unstable, steep stream banks caused by improper grazing techniques. This problem has been exacerbated by unusual weather patterns over recent years.

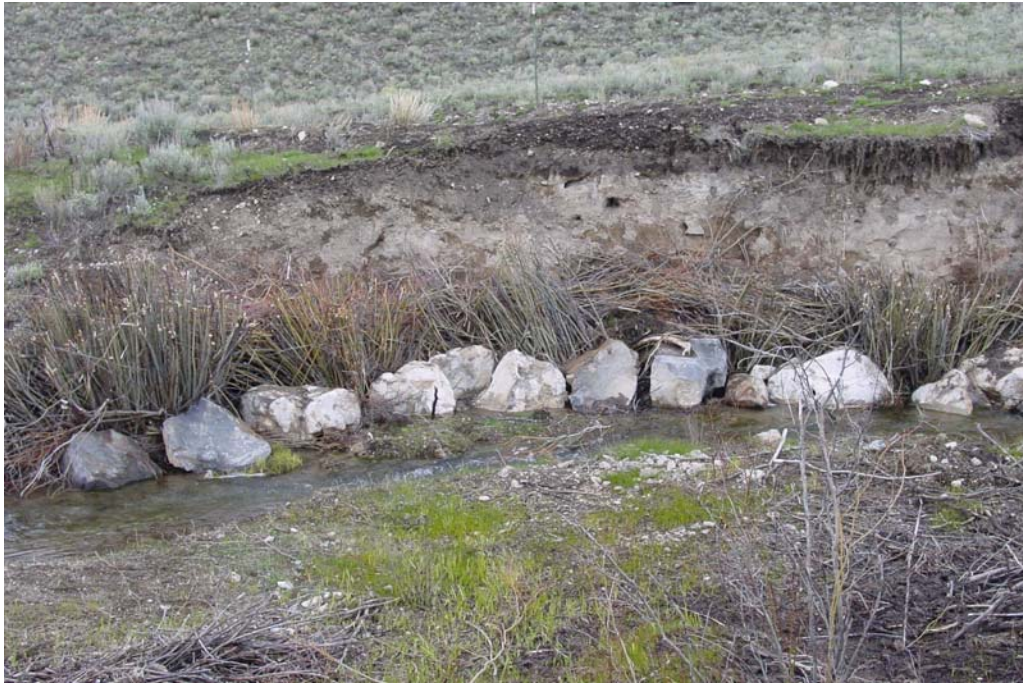
Figure 23: One solution to bank erosion is to carefully place rip-rap and woody vegetation at the toe of the bank. With time, this bank will become completely vegetated and stabilized.

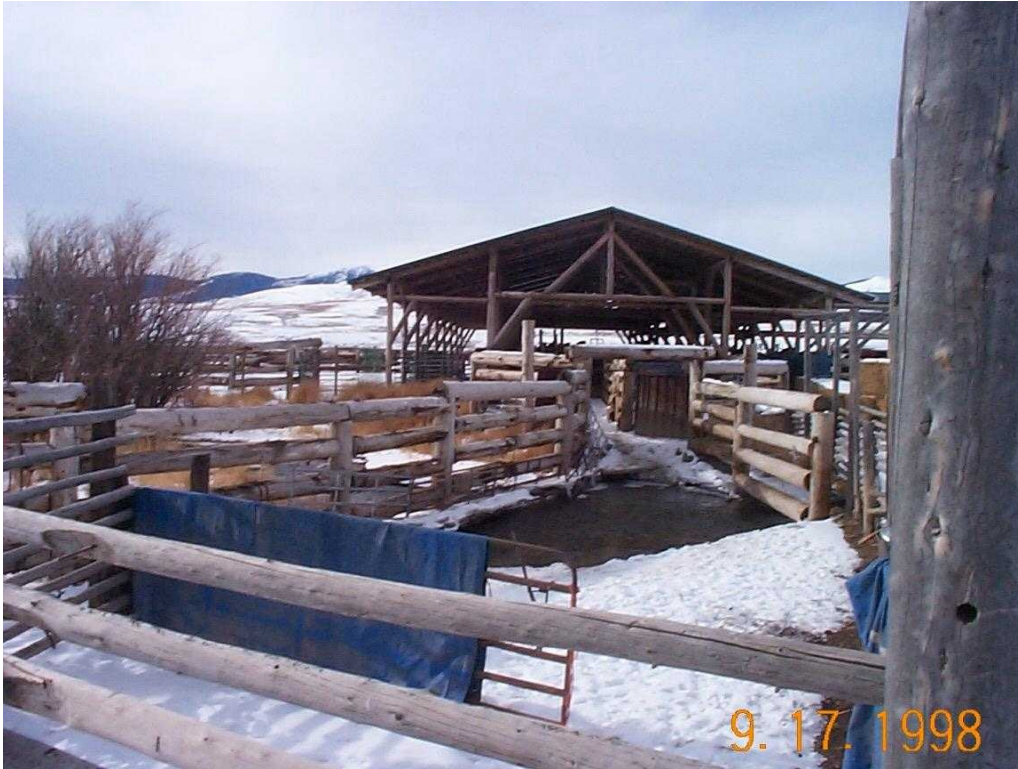
Figure 24: Confined Animal Feeding Operation relocated away from Irving Creek

Another common problem along Medicine Lodge Creek is that confined animal feeding operations (CAFOs) have historically been placed in and adjacent to streams in order to provide water for livestock. The CAFO seen in Figure 24 used to be located in Irving Creek. This facility was recently relocated away from Irving Creek and now has water piped into it.

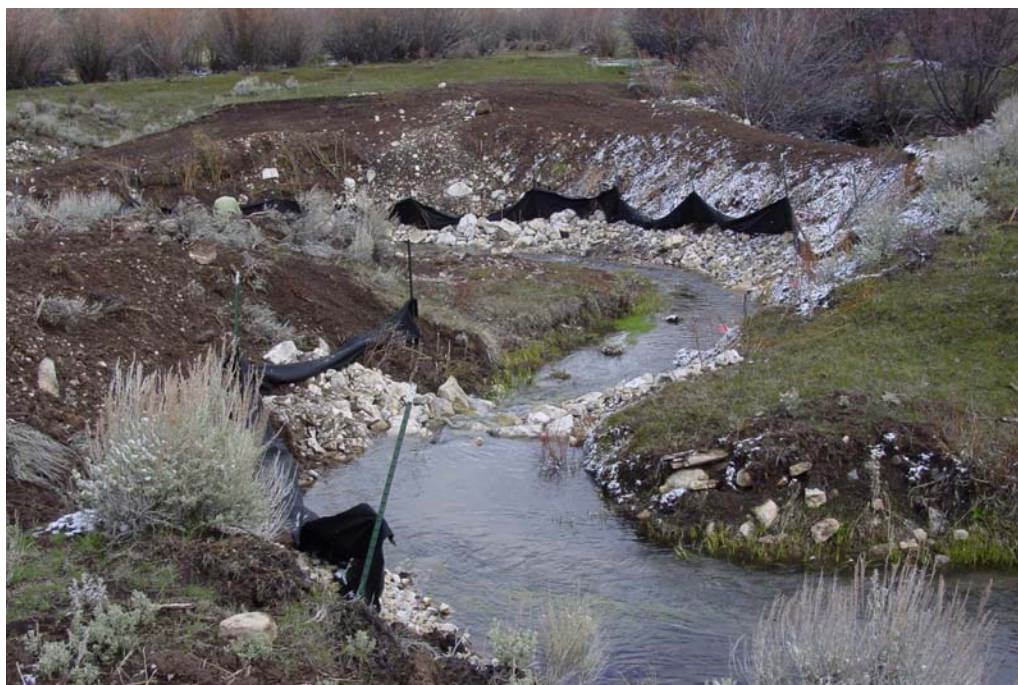
Figure 25: Vertical slopes from overgrazing were knocked down. Rip-rap and willows were added to stabilize the bank. This looks unsightly now but will appear quite natural after one or two growing seasons. The biodegradable silt fencing will break down.

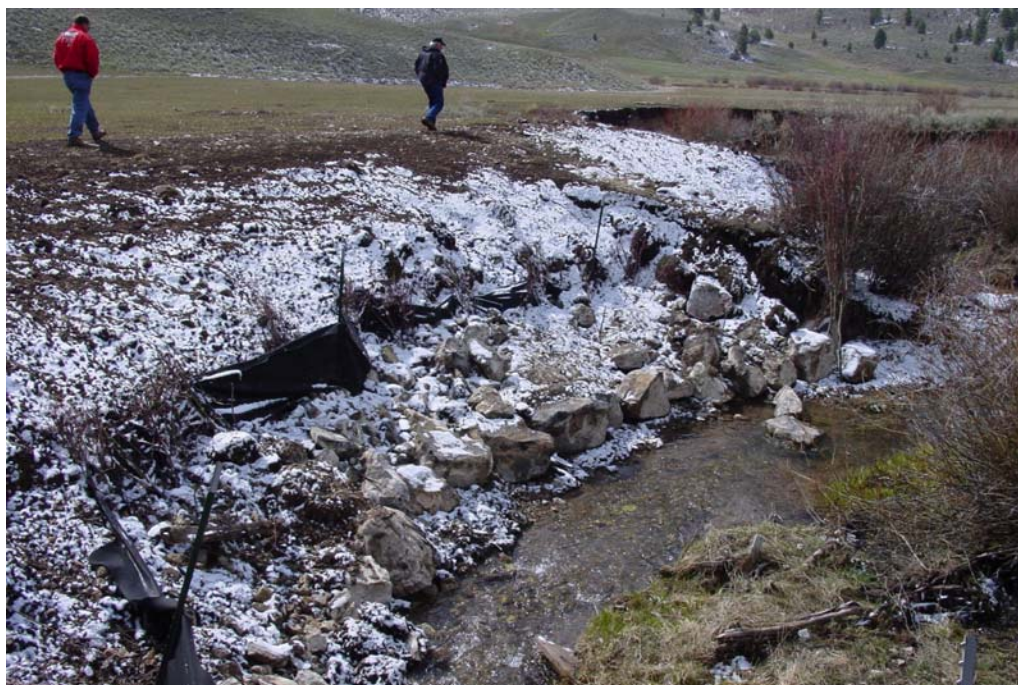
Figure 26: The stream bank in the foreground has been re-sloped, stabilized with rip-rap, and replanted. The vertical stream bank in the background has not yet been rehabilitated.

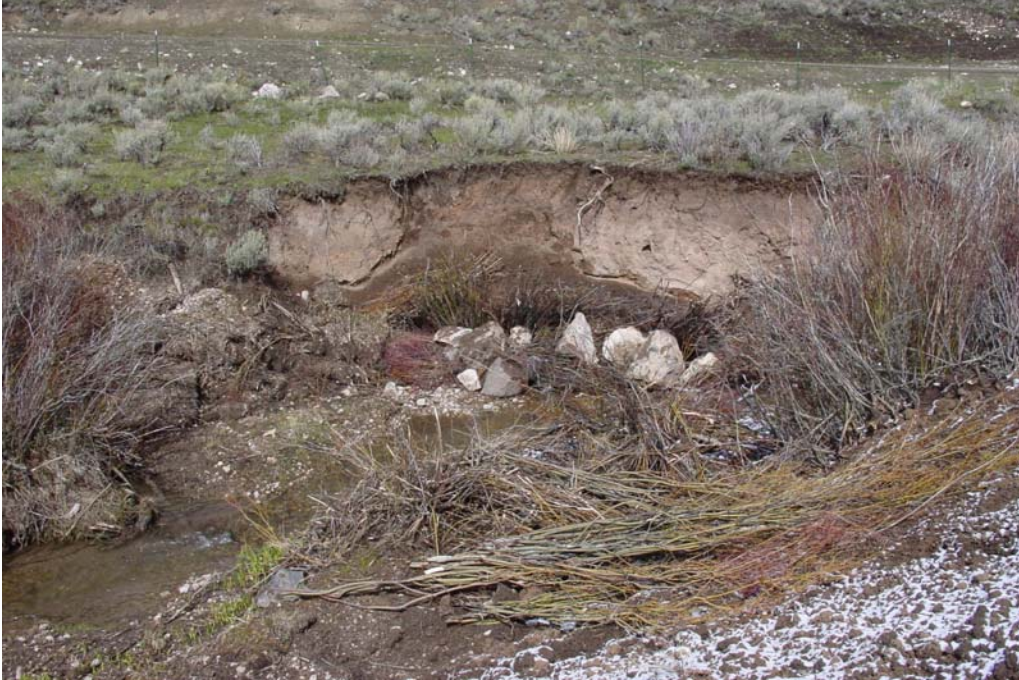
Figure 27: Willows were planted as horizontal bundles and as transplanted rooted clumps. All woody plants are locally derived. Many of the vertical banks were stabilized at their toe with large rocks and woody plants. The upper bank will slough back until stabilization is naturally achieved. Vegetation will then continue to establish itself naturally.

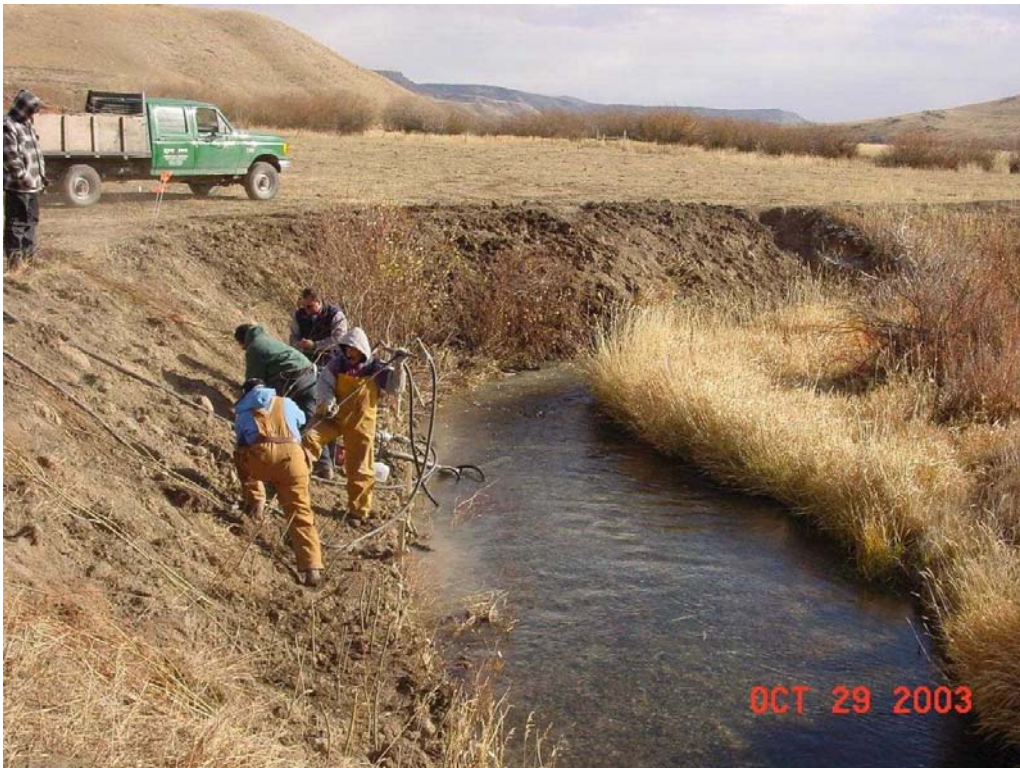
Figure 28: One effective method for planting willows involves the use of a water jet. This high-pressure water injection technique allows quick and easy planting of willow cuttings several feet deep along the bank and within the water table.

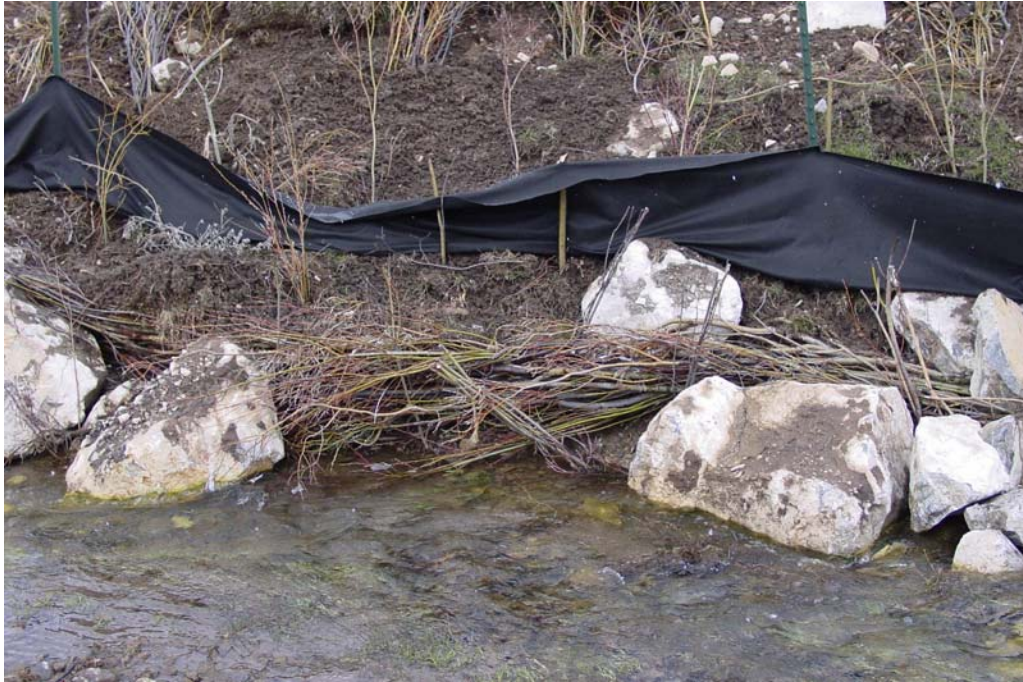
Figure 29: These willow cuttings were planted using water jet injection.

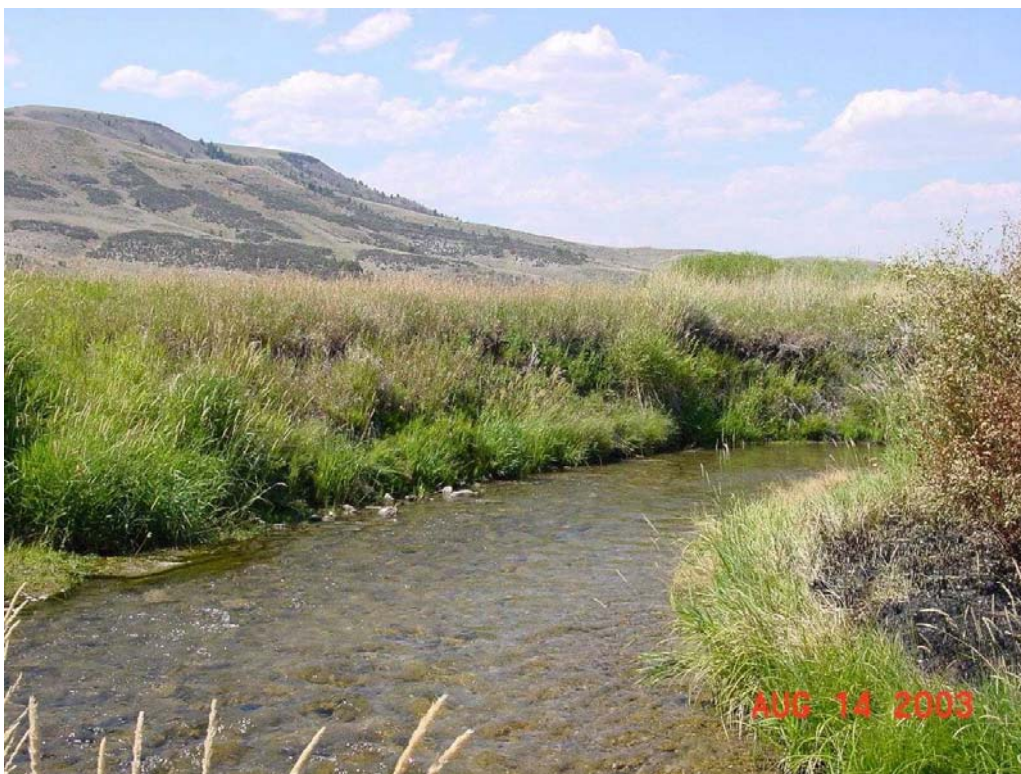
Figure 30: Within several years, all of the areas shown in the previous photographs will look as good and function as well as this section that was completed just two years ago.

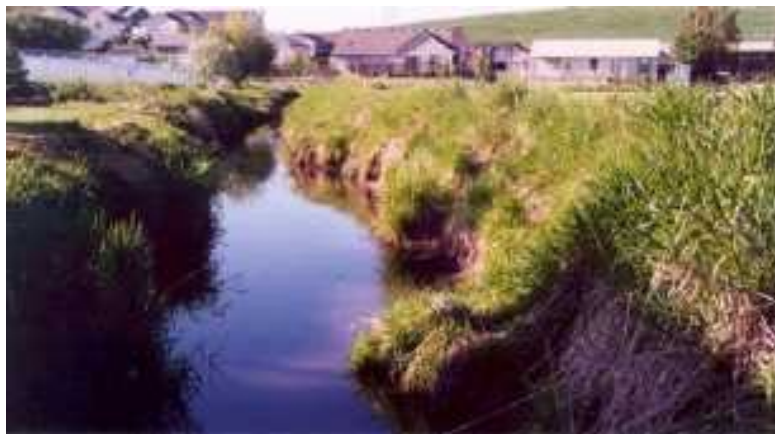
Figure 36: Bridge Street Park early Spring 2001

Previous Conditions: These stream segments had slumping, eroding banks that were frequently undercut during heavy storm events, contributing sediment to Paradise Creek (Figure 36). In addition, annual dredging artificially widened and incised the stream channel, causing raised water temperatures during low flow periods of the year. Reed canary grass was the dominant vegetation along this stream segment. Few trees or woody vegetation grew along the stream segment.

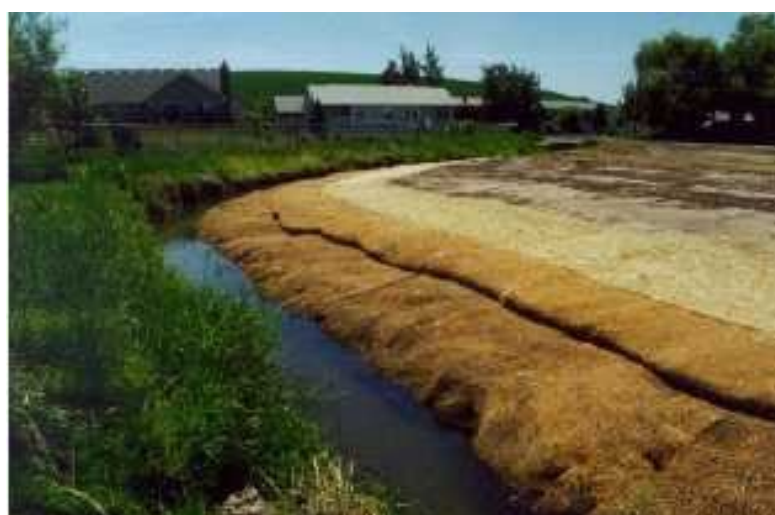
Figure 37: Bridge Street Park Summer 2001

Description of Completed Activity: The purpose of the Bridge Street Park project was to reconfigure approximately 450 linear feet of a straight, ditch-like creek to a low-flow channel with a terraced floodplain. Approximately 390 cubic yards of soil were excavated from this site. The newly constructed low-flow channel has a 3 to 4 foot bottom width, much reduced from the prior width of 8 feet, and will convey 1.5 to 2 year flows (Figure 37). Approximately 195 cubic yards of the excavated soil were used as backfill to create the two-tiered floodplain, with soil wraps to increase the flood storage capacity of this reach. These geotextile fabric-wrapped soil “burritos” were stacked one upon the other, and seeded with native grasses. Each soil wrap is about 6 feet wide and one foot high. The floodplain was constructed to 20 feet wide on the west side of the stream in Bridge Street Park. The local 10-year flood elevation was decreased by a maximum of 0.2 feet. The 100-year flood elevation was decreased by 0.1 feet upstream of the project. In the fall of 2001, woody shrubs and trees were planted along the bank to shade the stream.

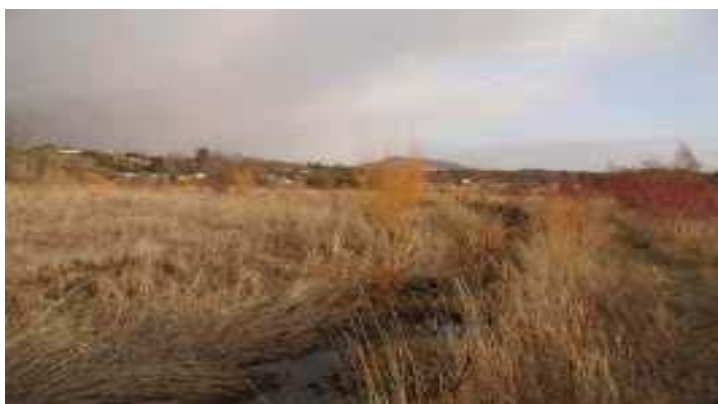
Figure 38: Carol Ryrie Brink Nature Park

Description of Completed Activity: The floodplain and stream banks were restored through excavation, stabilization, and planting of native riparian species. In the fall of 1995, it took Roach Construction of Genesee, Idaho one week to excavate a 5-acre floodplain and re-meander 1,200 feet of stream channel. Excavation activities moved 12,000 cubic yards of earth. Volunteers, including Moscow schoolchildren, University of Idaho and Washington State University students, and community members, built three 175-foot revetments for stabilization and demonstration purposes, including a log-crib revetment, a BioLog® revetment, and a root-wad and rock revetment. PCEI volunteers seeded and mulched over 3,000 square feet of stream bank and 5 acres of floodplain, installed over 6,000 square feet of geotextiles, and planted over 750 native plants. In total, it took about 2,000 volunteer hours to construct this project. The site (Figure 38) was later christened the “Carol Ryrie Brink Nature Park,” named for the popular author who grew up in Moscow.

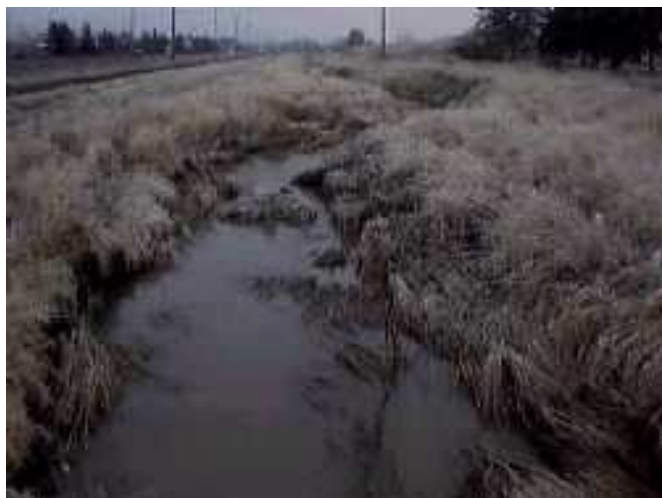
Figure 39: Chipman Trail Fall 1999

Previous Conditions: Weedy banks, devoid of woody vegetation, characterized this confined reach of Paradise Creek. The channel was dredged in the past and was wide, with steep, vertical banks. These conditions left the stream with eroding banks, high water temperatures, and minimal habitat value (Figure 39).

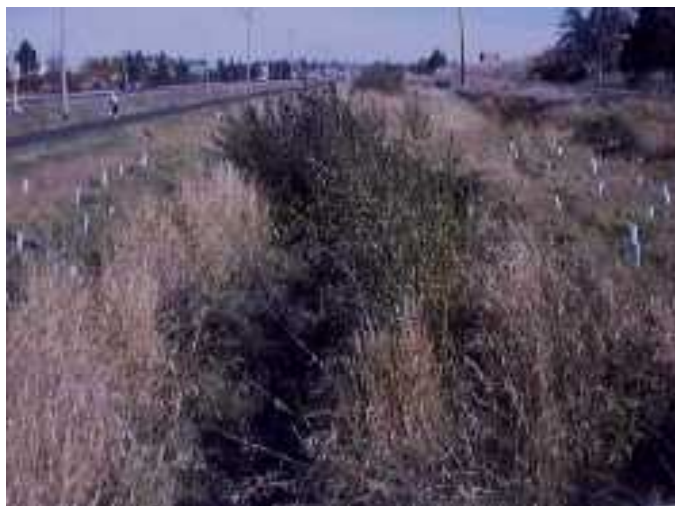
Figure 40: Chipman Trail Summer 2002

Description of Completed Activity: To stabilize the banks, native willow poles from the Wildlife Habitat Institute were planted with a post-hole tool on an excavator along the stream. In addition, over 2,000 native trees and shrubs were planted in approximately 40 foot wide buffer strips on either side of the creek (Figure 40). These will grow to shade the stream, helping moderate stream temperatures. Woody riparian buffers offer many benefits, including filtration of runoff, wildlife habitat, and floodwater retention. These plantings were protected from vole and beaver damage with plastic tubes, and were watered and weeded for the first two years. The City of Moscow Parks Department also cooperated with PCEI to plant native trees along the Chipman Trail, which parallels the

The second site consists of 1,799 feet of stream bank restoration where more willow poles were planted along the upstream end of the project. The willows will provide shade to reduce stream temperatures, stabilize the steep stream banks, and contribute woody material to the stream. Maintenance of past plantings, including watering and weeding, was performed during the summers of 2002 and 2003.

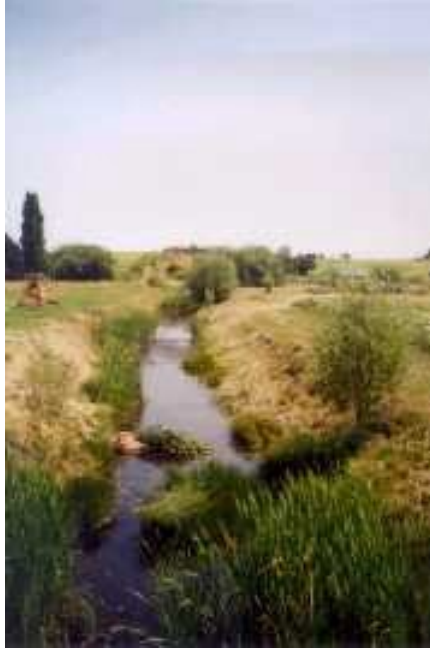
Figure 41: Before Spring 2000

Previous Conditions: This reach of Paradise Creek had a straightened, excessively wide channel with nearly vertical, eroding stream banks. The stream channel had been straightened, deepened, and widened by years of dredging (Figure 41). The steep banks were undercut during high flows, contributing to the sediment load in the creek. Reed canary grass was the dominant bank vegetation, and no native woody vegetation was present to control bank erosion or shade the stream.

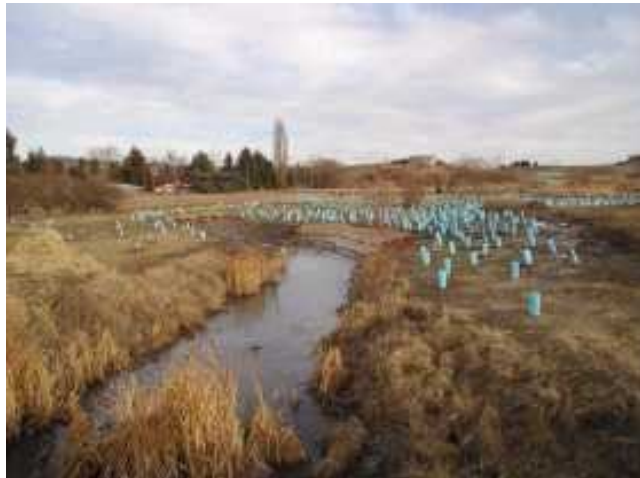
Figure 42: East Mt. View late Winter 2002

All bare soil was seeded with native grasses following construction. Native herbaceous vegetation, such as small-fruited bulrush, common rush, and Nebraska sedge were planted along the toe of the channel slope. Red-osier dogwood plugs and willow plugs and poles were planted on the stream banks to provide long-term bank stabilization and to shade the stream. A mix of native trees and shrubs, including aspen, ninebark, Nootka rose, ponderosa pine, syringa, and serviceberry were planted on the floodplain.

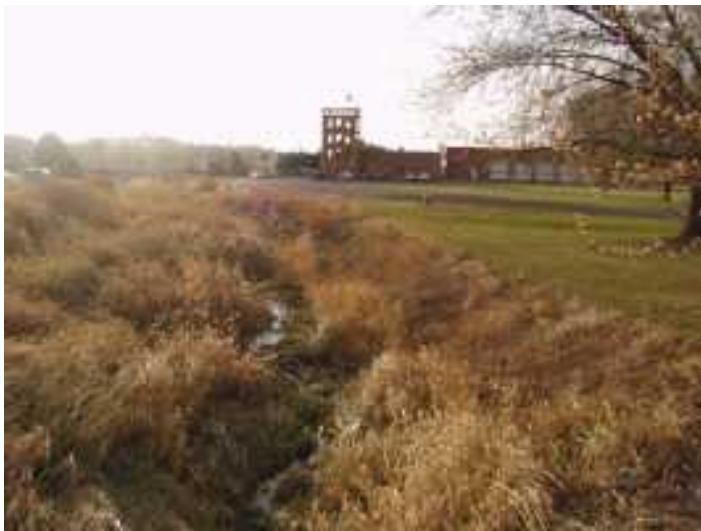
Figure 43: Fire Station Stream Bank Stabilization

Previous Conditions: The stream segment had nearly vertical, slumping, eroding stream banks contributing to the sediment load in the creek. There was also a lack of native woody vegetation close to the creek for shade. Paradise Creek had been dredged in this reach many times, which added to its degraded state.

Description of Completed Activity: This project stabilized a highly impacted area of the stream bank and added a riparian buffer. Due to the confined nature of the stream at this point, and the close proximity to the Moscow Fire Station, a small area of rip-rap was placed in conjunction with coconut fiber Biologs® along the upstream portion of the project. Erosion control fabric was installed on the remaining portion of the stream bank. The Biologs® were planted with native herbaceous plugs. All exposed stream banks were seeded with native grasses, and woody shrubs were planted on the banks and at the top of the stream bank (Figure 43).

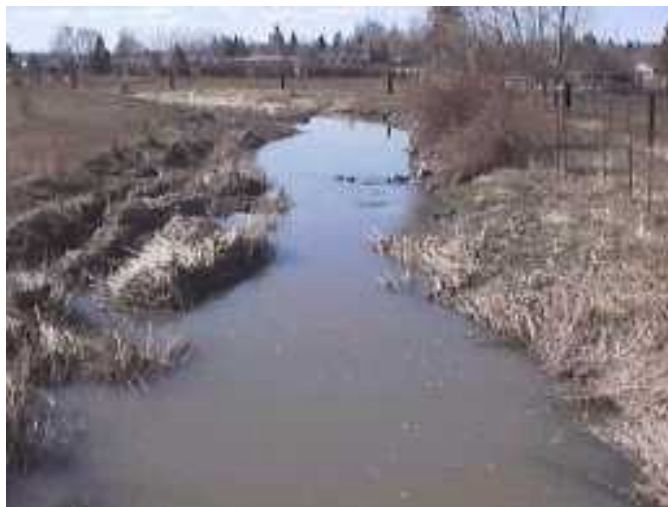
Figure 44: Fosberg area prior to planting

Previous Conditions: This site was previously used as pasture and the landowners decided to retire the land from grazing, so the property was entered into a land easement with the Palouse Land Trust. The riparian area was dominated by a monoculture of reed canary grass, which provides little shade, sediment retention, or wildlife habitat (Figure 44).
